Acoustical Solutions 2420 Grenoble Road, Richmond Virginia 23294

Date: 9th November 2023

Ref: Acoustical Solutions Wall Assembly In-field Testing

Cullum: PA1109C

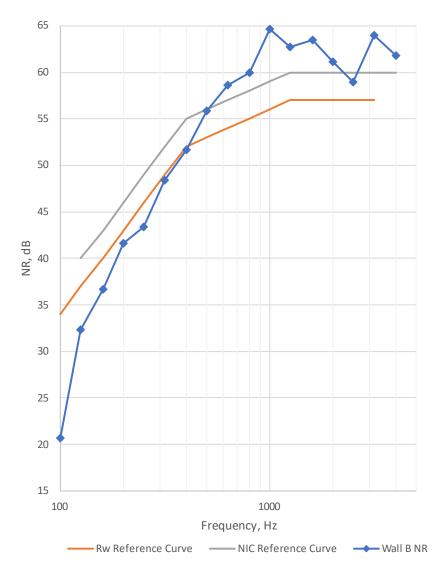
7.2 Wall B

NR	Issues
100	20.7	
125	32.3	
160	36.6	
200	41.6	*
250	43.4	*
315	48.4	*
400	51.7	*
500	55.9	*
630	58.7	
800	60.0	
1000	64.6	*
1250	62.7	
1600	63.5	
2000	61.1	*
2500	58.9	*
3150	64.0	*
4000	61.8	*

7.2.1 Rw = 53

7.2.2 NIC = 56

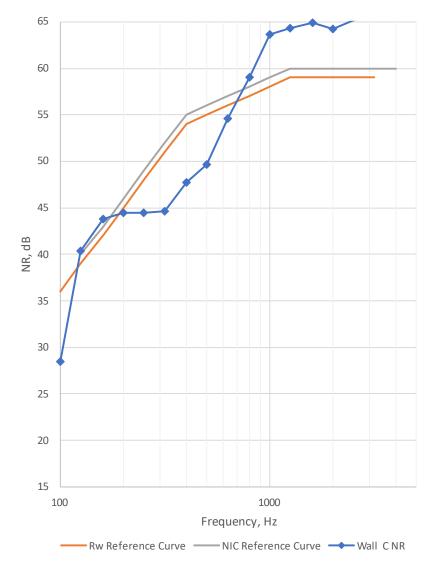
7.3 Wall C

NR	Issues
100	28.5	*
125	40.4	+
160	43.8	*+
200	44.5	*
250	44.5	*
315	44.7	*
400	47.7	*
500	49.7	*
630	54.6	*
800	59.0	*
1000	63.6	*
1250	64.3	*
1600	64.9	*
2000	64.2	*
2500	65.2	
3150	65.7	
4000	68.9	*

7.3.1 Rw = 55

7.3.2 NIC = 56

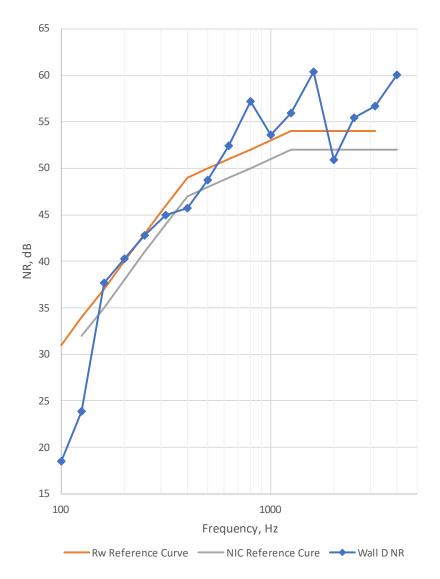
7.4 Wall D

NR	Issues
100	18.5	
125	23.8	
160	37.7	
200	40.3	*
250	42.8	*
315	45.0	*
400	45.7	*
500	48.8	*
630	52.4	*
800	57.2	*
1000	53.6	*
1250	55.9	*
1600	60.4	*
2000	50.9	*
2500	55.4	*
3150	56.7	*
4000	60.0	*

7.4.1 Rw = 50

7.4.2 NIC = 48

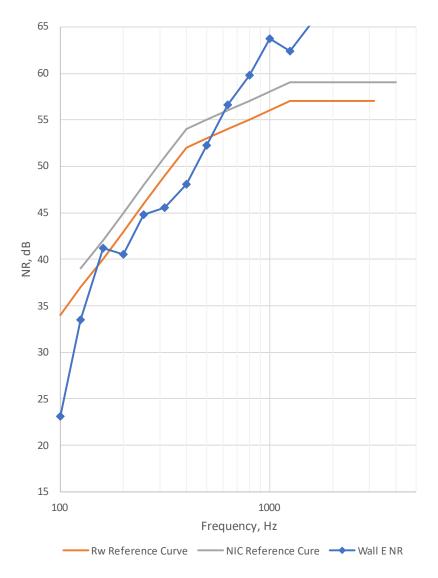
7.5 Wall E

NR	Issues
100	23.1	
125	33.5	
160	41.2	
200	40.5	
250	44.8	*
315	45.6	
400	48.0	
500	52.3	
630	56.6	
800	59.8	*
1000	63.7	*
1250	62.4	*
1600	65.6	*۸
2000	67.8	*۸
2500	69.8	٨
3150	68.5	*۸
4000	72.0	*۸

7.5.1 Rw = 53

7.5.2 NIC = 55

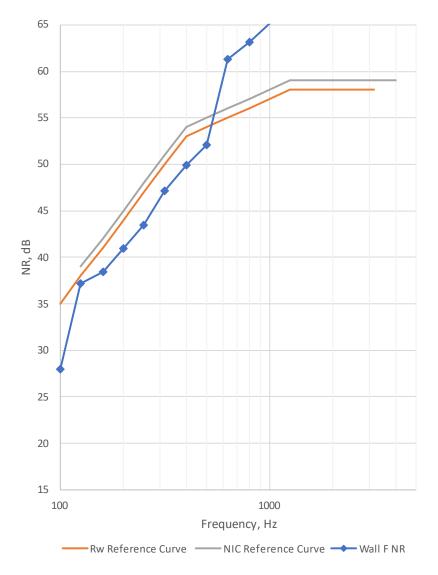
7.6 Wall F

NR	Issues
100	28.0	
125	37.2	
160	38.4	
200	41.0	
250	43.5	
315	47.2	
400	49.9	
500	52.1	
630	61.3	
800	63.1	
1000	65.2	
1250	67.0	
1600	70.2	*
2000	71.0	
2500	73.8	
3150	74.2	
4000	77.6

7.6.1 Rw = 54

7.6.2 NIC = 55

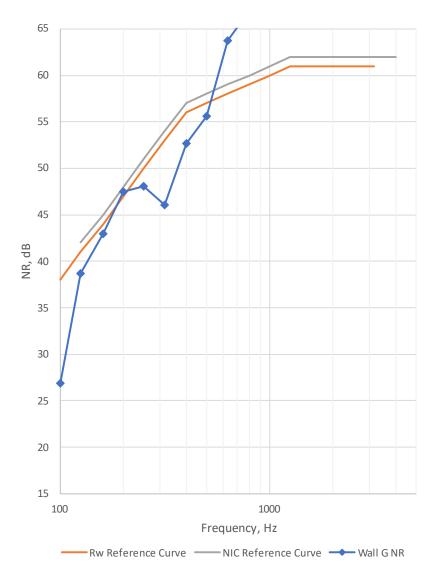
7.7 Wall G

NR	Issues
100	26.9	
125	38.7	
160	43.0	
200	47.4	
250	48.0	
315	46.1	
400	52.6	
500	55.6	
630	63.7	*
800	67.0	
1000	67.9	
1250	67.7	
1600	70.3	
2000	74.6	
2500	76.9	
3150	75.9	
4000	77.3

7.7.1 Rw = 57

7.7.2 NIC = 58

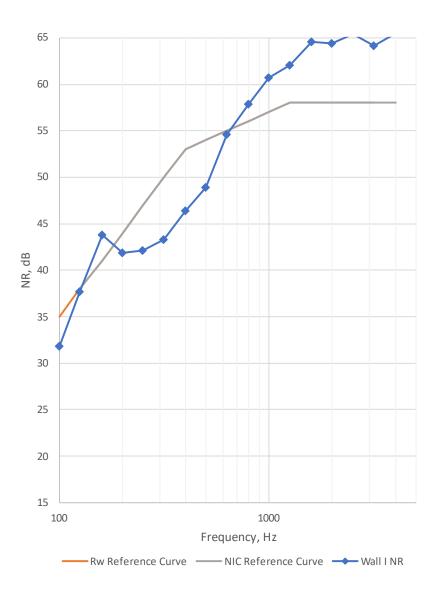
7.9 Wall I

NR	Issues
100	31.8	*
125	37.7	*
160	43.8	*
200	41.8	*
250	42.1	*
315	43.3	*
400	46.4	*
500	48.9	*
630	54.6	*
800	57.9	
1000	60.7	*
1250	62.0	*
1600	64.6	*
2000	64.4	*
2500	65.4	*
3150	64.2	*
4000	65.5	*

7.9.1 Rw = 54

7.9.2 NIC = 54

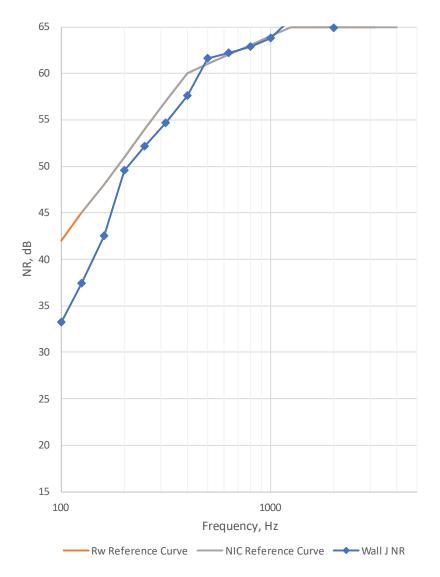
7.10 Wall J

NR	Issues
100	33.2	
125	37.4	
160	42.5	
200	49.5	
250	52.1	*
315	54.7	
400	57.6	*
500	61.6	
630	62.2	
800	62.8	*
1000	63.8	
1250	65.9	
1600	66.5	
2000	64.9	
2500	66.8	
3150	68.3	
4000	70.7

7.10.1 Rw = 61

7.10.2 NIC = 61

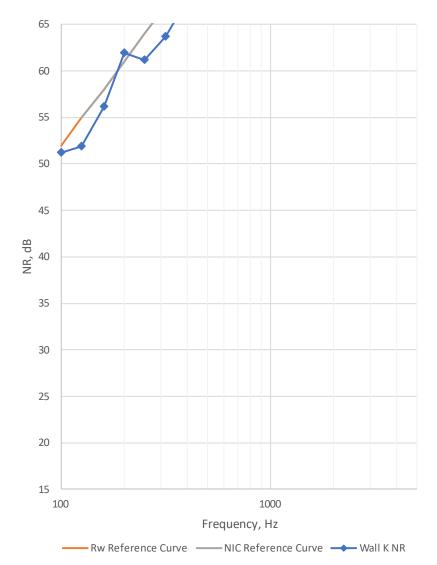
7.11 Wall K

NR	Issues
100	51.2	
125	51.9	
160	56.2	
200	61.9	
250	61.2	
315	63.7	
400	67.6	
500	71.5	*
630	70.4	
800	71.9	
1000	71.4	
1250	73.2	
1600	74.1	
2000	74.9	
2500	69.3	
3150	75.1	
4000	76.4	٨

7.11.1 Rw = 71

7.11.2 NIC = 71

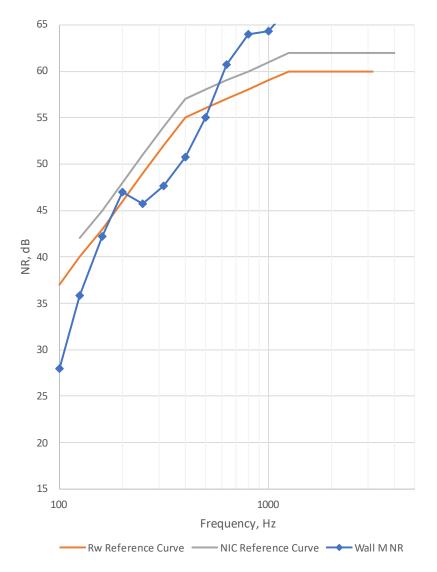
7.12 Wall M

NR	Issues
100	28.0	*
125	35.8	*
160	42.2	
200	47.0	*
250	45.7	
315	47.6	*
400	50.8	*
500	55.0	*
630	60.7	*
800	64.0	*
1000	64.3	*
1250	66.9	*
1600	70.9	*
2000	70.8	*
2500	67.3	
3150	72.9	
4000	73.7

7.12.1 Rw = 56

7.12.2 NIC = 58

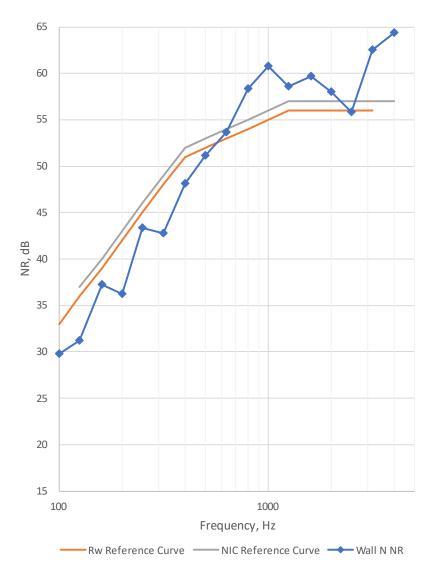
7.13 Wall N

NR	Issues
100	29.8	
125	31.2	
160	37.3	
200	36.2	
250	43.4	
315	42.7	
400	48.2	
500	51.2	
630	53.6	
800	58.3	
1000	60.8	
1250	58.6	
1600	59.7	
2000	58.0	
2500	55.8	
3150	62.5	
4000	64.4

7.13.1 Rw = 52

7.13.2 NIC = 53

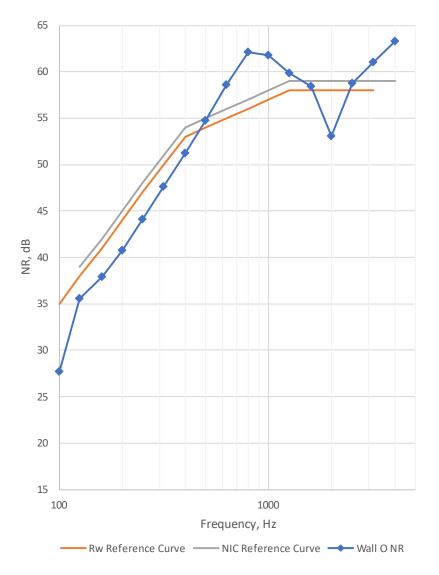
7.14 Wall O

NR	Issues
100	27.7	
125	35.6	
160	37.9	
200	40.7	
250	44.1	
315	47.6	
400	51.2	
500	54.8	*
630	58.6	
800	62.1	
1000	61.8	*
1250	59.8	
1600	58.4	
2000	53.1	
2500	58.8	
3150	61.0	
4000	63.3

7.14.1 Rw = 54

7.14.2 NIC = 55

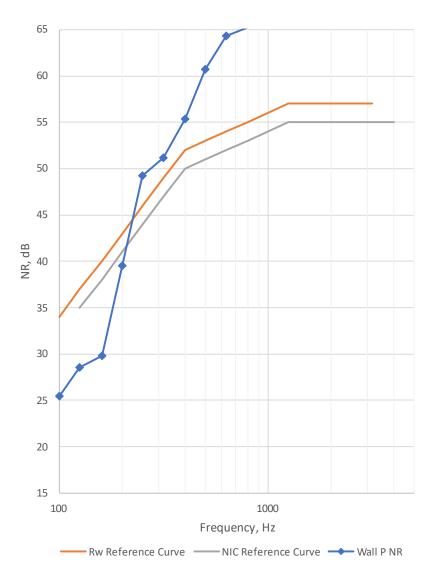
7.15 Wall P

#8 is out of position based on the prediction of expected construction. This construction should performance closer to rank #3 (Rw 59) but was measured at Rw 53. A secondary prediction was created, which omits the insulation of the wall (the construction should have included insulation). This yielded a prediction of Rw 52 – much closer to the as-measured performance and may explain the difference relative to expectation.

After on-site inspection of the wall construction, it was found that the construction is correct, but inside this wall (and the surveyed area) was a wastewater pipe. This would be equivalent to "no insulation" and/or sound from the ceiling plenum could enter the pipe and reduce acoustic performance. This explains the lack of performance of this assembly.

NR	Issues
100	25.5	
125	28.5	
160	29.8	
200	39.5	
250	49.2	*
315	51.2	*
400	55.4	*
500	60.7	*
630	64.3	*^
800	65.2	*
1000	67.9	٨
1250	67.3	*
1600	78.4	*+^
2000	76.4	*+
2500	70.4	
3150	65.6	*
4000	66.1	*

7.15.1 Rw = 53

7.15.2 NIC = 51
